HMVT

Specialist in-situ soil and groundwater remediation

Case 1: MPE and ISCO Kerosene Spill Ermelo

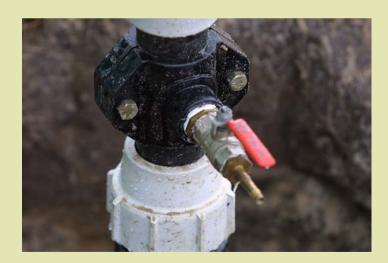
Site characteristics

Site: Ermelo (The Netherlands)

Pollutant: LNAPL of Kerosene

Depth: 12 m below GL

Amount: 6,000 kg of product

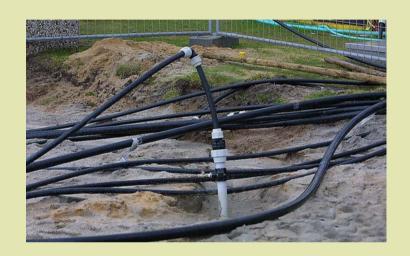
Remediation techniques

Excavation of polluted soil to 3 m-gl Multi-Phase-Extraction (MPE) Chemical oxidation (Fenton's reagents)

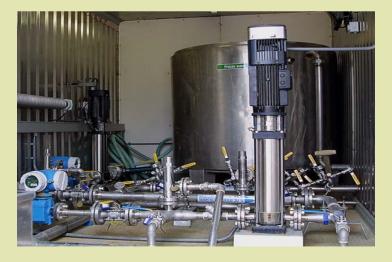
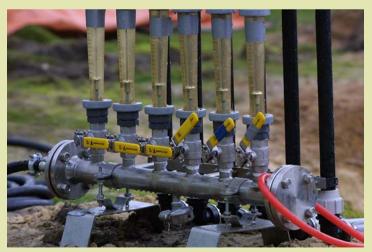
MPE extraction:

- short extraction filters (15 filters)
- position in LNAPL layer
- high vacuum extraction (0.4 to 0.9 bar)

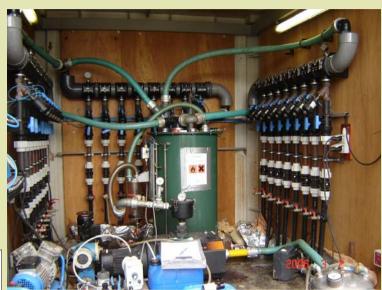
ISCO:

- injection lances (22 lances)
- soil vapor extraction (polluted gasses)
- using Fenton's reagents

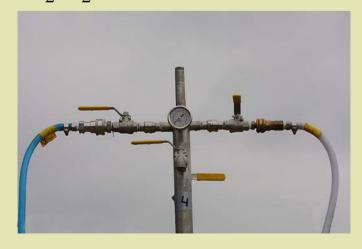
Fenton's reagents:

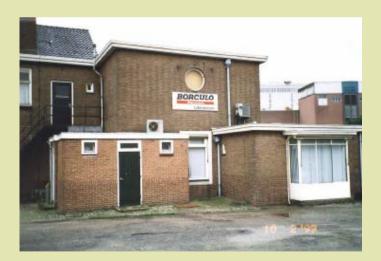
Site characteristics

Site: Borculo (The Netherlands)

Pollutant: Diesel

Depth: 1.5 m below GL

Max. concentration: 4,700 ug/l

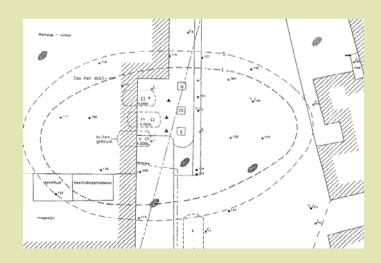
In-situ system

- 25 air sparging filters
- 14 air extraction filters
- 23 dual phase extraction filters
- 32 injection filters for nutrients

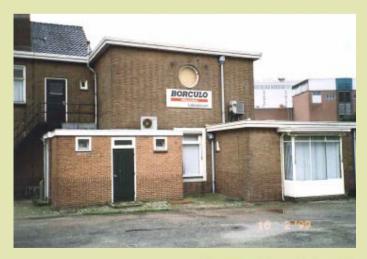
<u>Treatment system (ex-situ)</u>

- Dual Phase extraction system
- Oil-water separator
- Stripping tower
- Activated carbon later on Retox (air treatment)

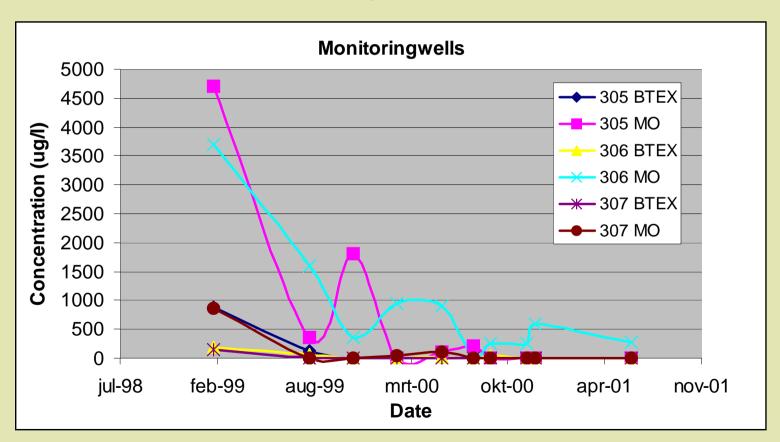
Decrease of concentration in groundwater

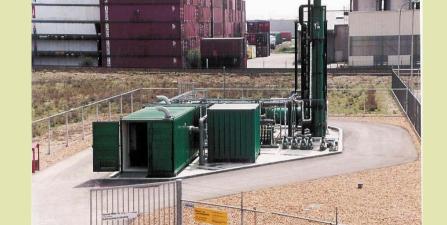
Phase 1: LNAPL Remediation

Phase 2: Air sparging combined with soil vapor extraction

Phase 3: Air sparging and bio sparging

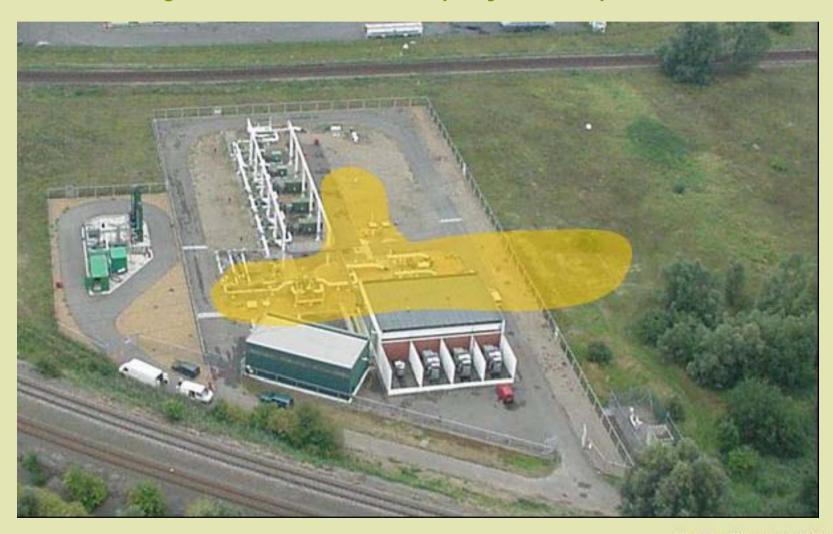
Case 3: Design&Construct Int. company Antwerp

First phase: LNAPL remediation

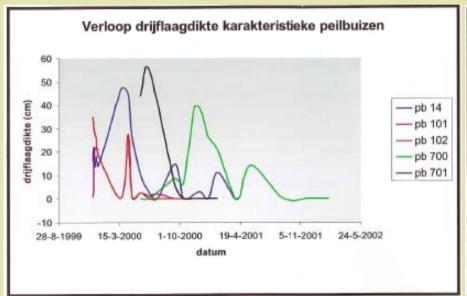
LNAPL removal

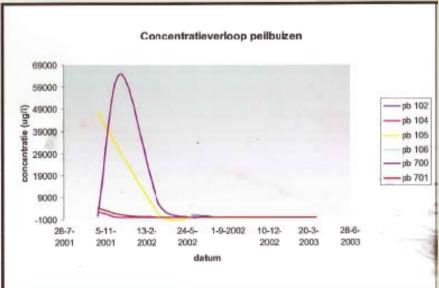
Concentration

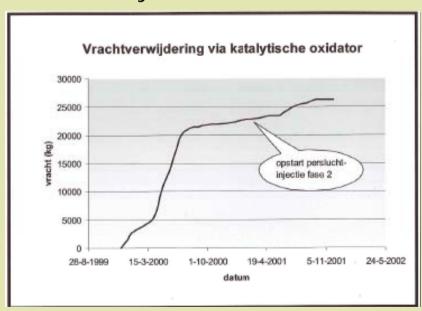
Removal by air treatment

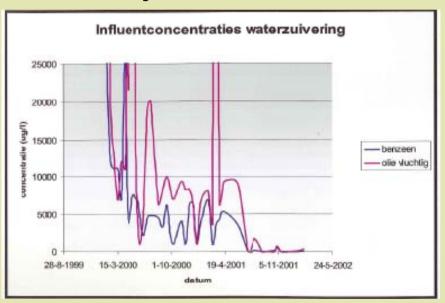
Removal by water treatment

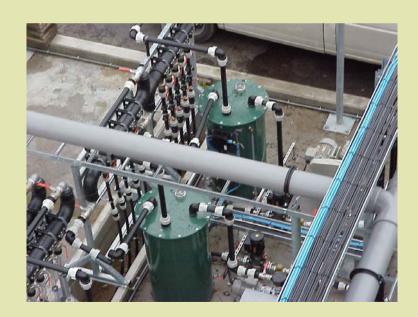
Second phase: Groundwater treatment

- Air sparging/bio venting
- Dual phase extraction
- Groundwater extraction

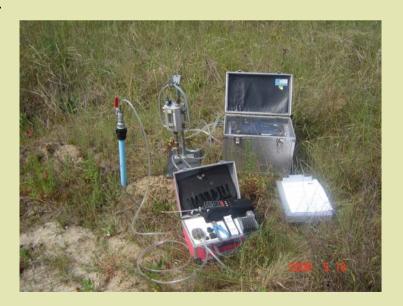
Third Phase: Air sparging/bio sparging

- Stimulation biological degradation by injection of air
- Injection in unsaturated en saturated zone
- Monitoring biological environment
